Proposed Develpments in Piti-Asan Watershed

### **Potential Soil Loss**

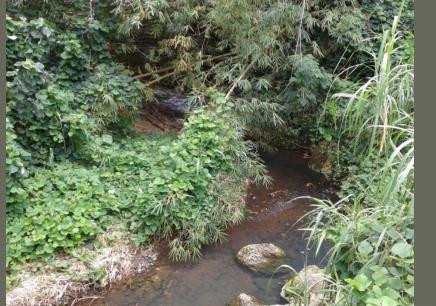
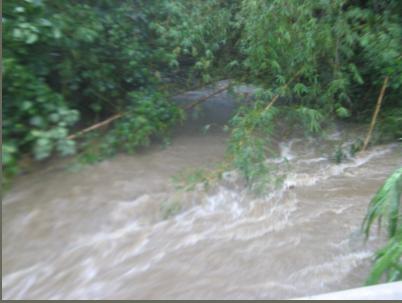
### Field Observations - Geus

Geus River before Tropical Storm Halong (7/18/2014). Same location after Tropical Storm Halong (7/30/2014).
